BIRD STRIKE CAPABILITIES OF TRANSPARENT AIRCRAFT
WINDSHIELD MATERIALS. PART II. SUPPLEMENTAL
EVALUATION OF PARAMETERS AFFECTING MATERIALS RESPONSE

Goodyear Aerospace Corporation

AFML-TR-74-234
Part II

Part II. Supplemental Evaluation of Parameters Affecting Materials Response

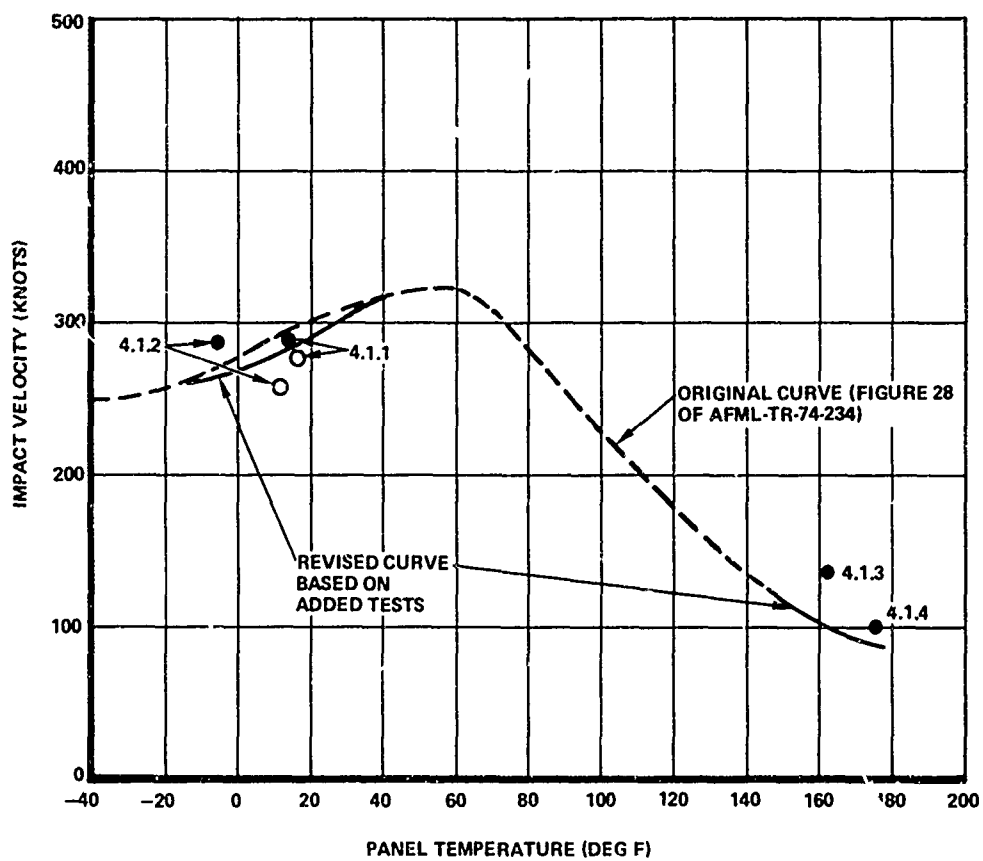
Figure 6. Effect of Panel Temperature on Penetration Velocity for Optically Treated 0.50-In. Polycarbonate at 45-Deg Bird Impact Angle

of the curve, and two at the high-temperature end. The latest test results are shown in Figure 6 along with the curve based on the earlier tests in AFML-TR-74-234. A minor revision in the penetration velocity curve is indicated near the low-temperature end as shown in Figure 6. The test results at elevated temperatures were consistent with prior results, and the penetration velocity curve has been extended to reflect these results.

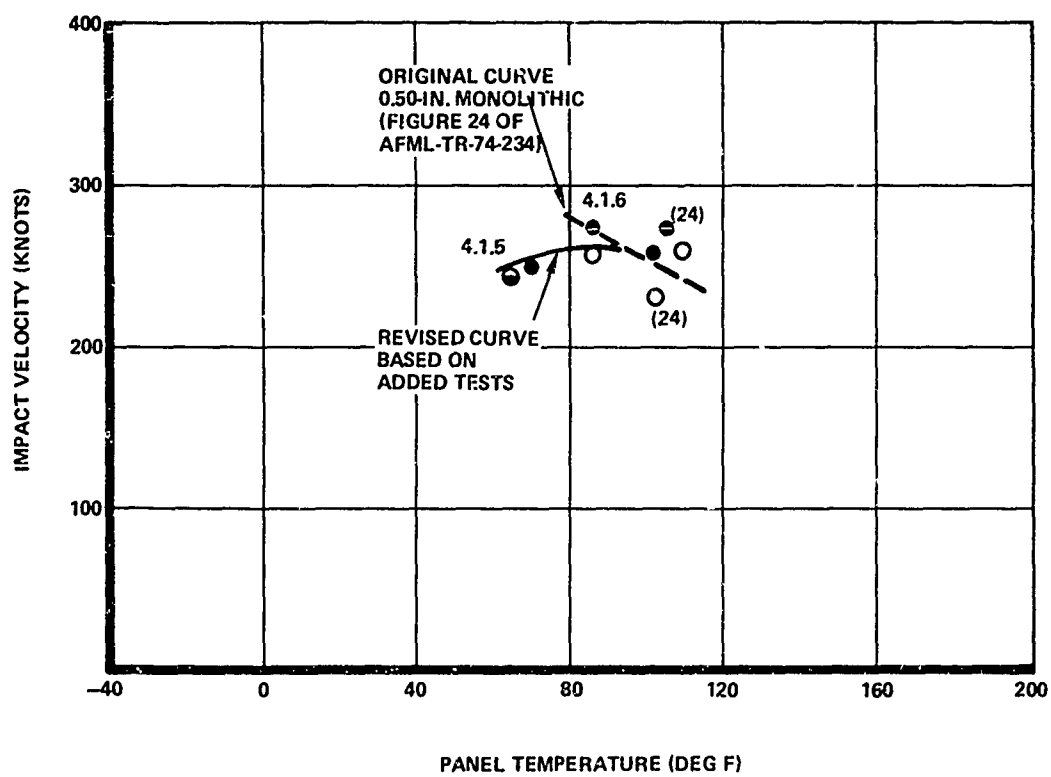
Figure 7. Effect of Panel Temperature on Penetration Velocity for 0.50-In. Fusion-Bonded Polycarbonate at 20-Deg Bird Impact Angle

The earlier tests of the 0.50-in. flat monolithic fusion-bonded polycarbonate panels at the 20-deg bird impact angle showed penetration velocities which appeared to be low and inconsistent with the results from tests at other angles. This inconsistency for the 0.50-in. material is easily noted in Figures 43 and 51 of AFML-TR-74-234. However, these earlier tests were made at panel temperatures from 100 to 110 deg F, so it was necessary to extrapolate the data back to the room temperature point. To be sure of this extrapolation, two more panels (numbers 4.1.5 and 4.1.6 of Table 9) were tested near room temperature. The results were essentially the same as previously reported, so the data as presented in AFML-TR-74-234 for this set of parameters are correct and no revisions are necessary. However, a revised temperature effects curve (Figure 7) is presented here to add the results from these latest tests.

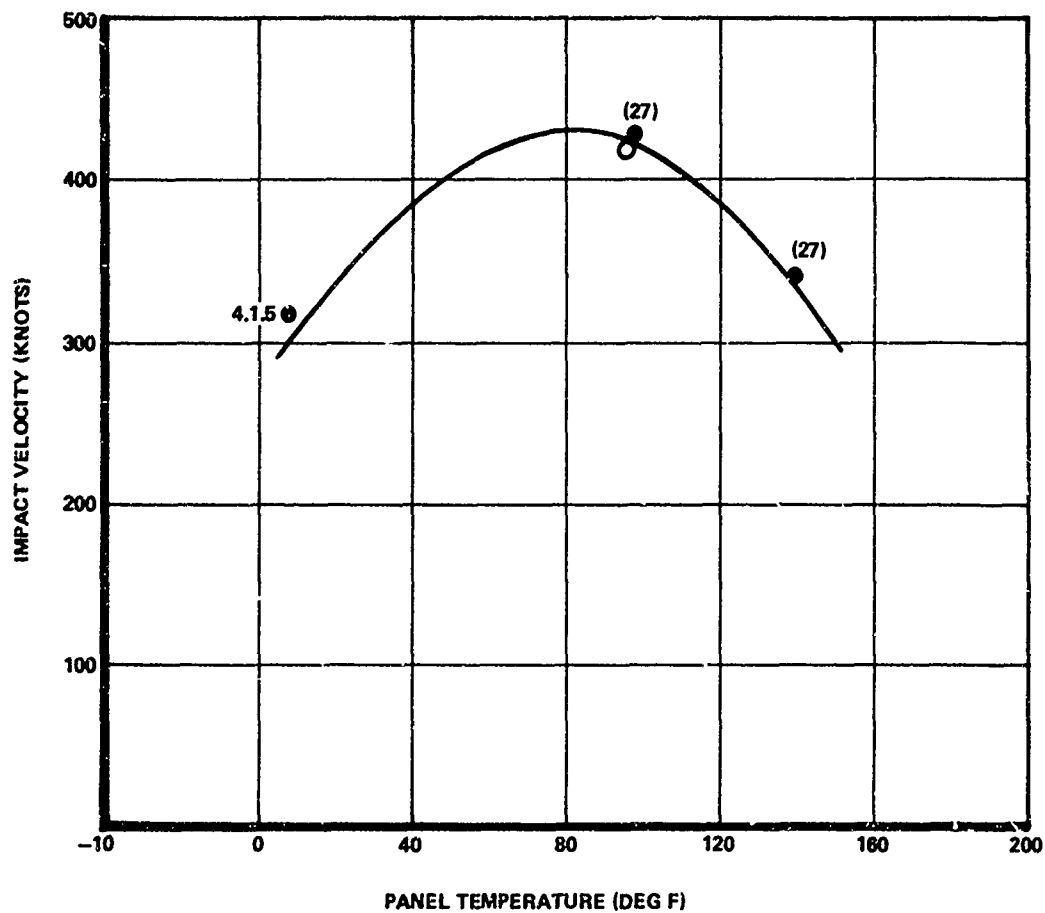
Figure 18. Effect of Panel Temperature on Penetration Velocity for 0.50-In. As-Extruded Polycarbonate at 30-Deg Bird Impact Angle

One monolithic flat panel of 0.50-in. as-extruded polycarbonate was also tested at the 30-deg bird impact angle at a reduced panel temperature. The purpose of this test was to supplement the data previously presented in Figure 27 of AFML-TR-74-234 by providing a data point at the low-temperature end of the scale. The results are presented in Figure 18 together with the prior results at other test temperatures.

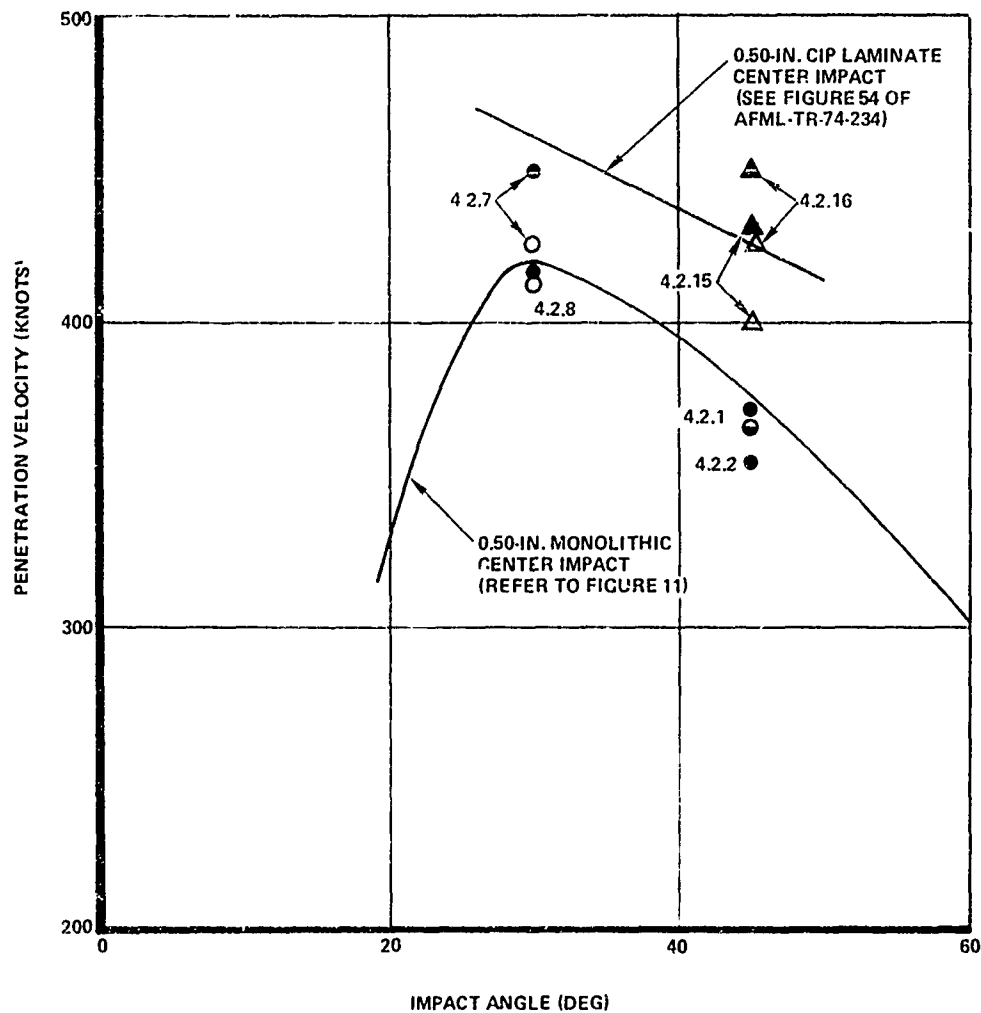
Figure 19. Comparison of Effect of Center Edge Impacts versus Center Impacts on Penetration Velocity at Various Bird Impact Angles for As-Extruded Monolithic Polycarbonate

For the 0.50-in.-thick panels, the penetration velocities for the center edge impacts were essentially the same as those recorded for center impacts for equivalent test panels and test conditions. Variations from the center hit penetration velocities did not exceed five percent. Failure modes were similar to those for the center impacts. Figure 19 presents a comparison of the edge impacts with center impacts for the 0.50-in. monolithic and laminated panels.

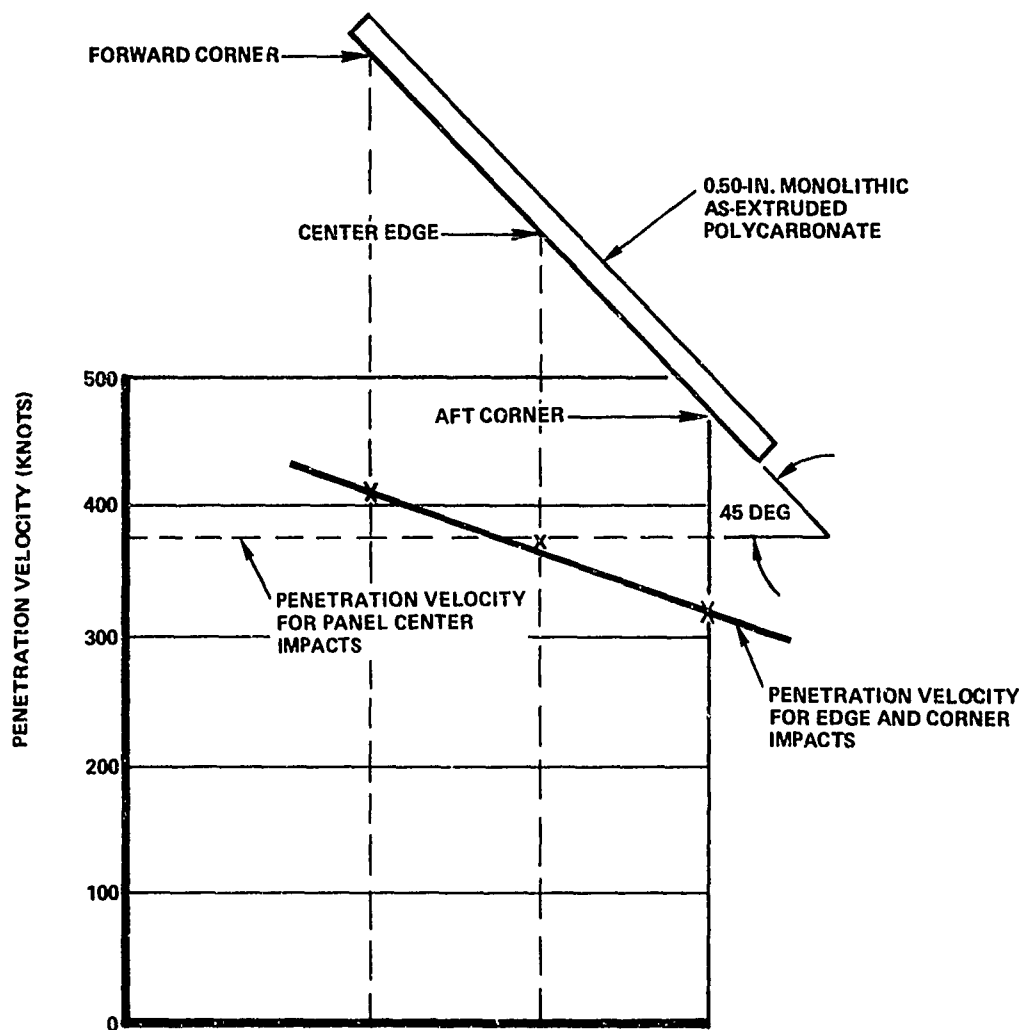
Figure 23. Effect of Impact Location on Penetration Velocity for 0.50-In. Monolithic As-Extruded Polycarbonate

velocities about 8 percent higher than were achieved for impacts at the geometric center of 0.50-in. monolithic polycarbonate panels. This slight increase may be because as the bird impacts and spreads out, a portion of the impact loads is transferred directly to the support frame. Also, some bird mass is soon deflected off the nearer edge of the panel and the panel is no longer required to apply work to that portion of the bird mass. The impacts in the rear corner of the monolithic panel were 16 percent lower than the center impacts at the 45-deg bird impact angle. Severe panel deflections and pocketing of the bird in the rear corner accounts for the lower penetration velocities for this condition. At the 30-deg bird impact angle, the penetration velocity for the rear corner impact is about 22 percent less than that for an impact in the panel center. Again, this is due to the severe pocketing with the failure mode consisting of local failure of the panel along the inside edge of the support frame (see Figure 21). Figure 22 presents a plot of the test results along with the curve for the center impacts on the 0.50-in. monolithic material. Figure 23 summarizes the effects of impact location for the 0.50-in. monolithic polycarbonate material.

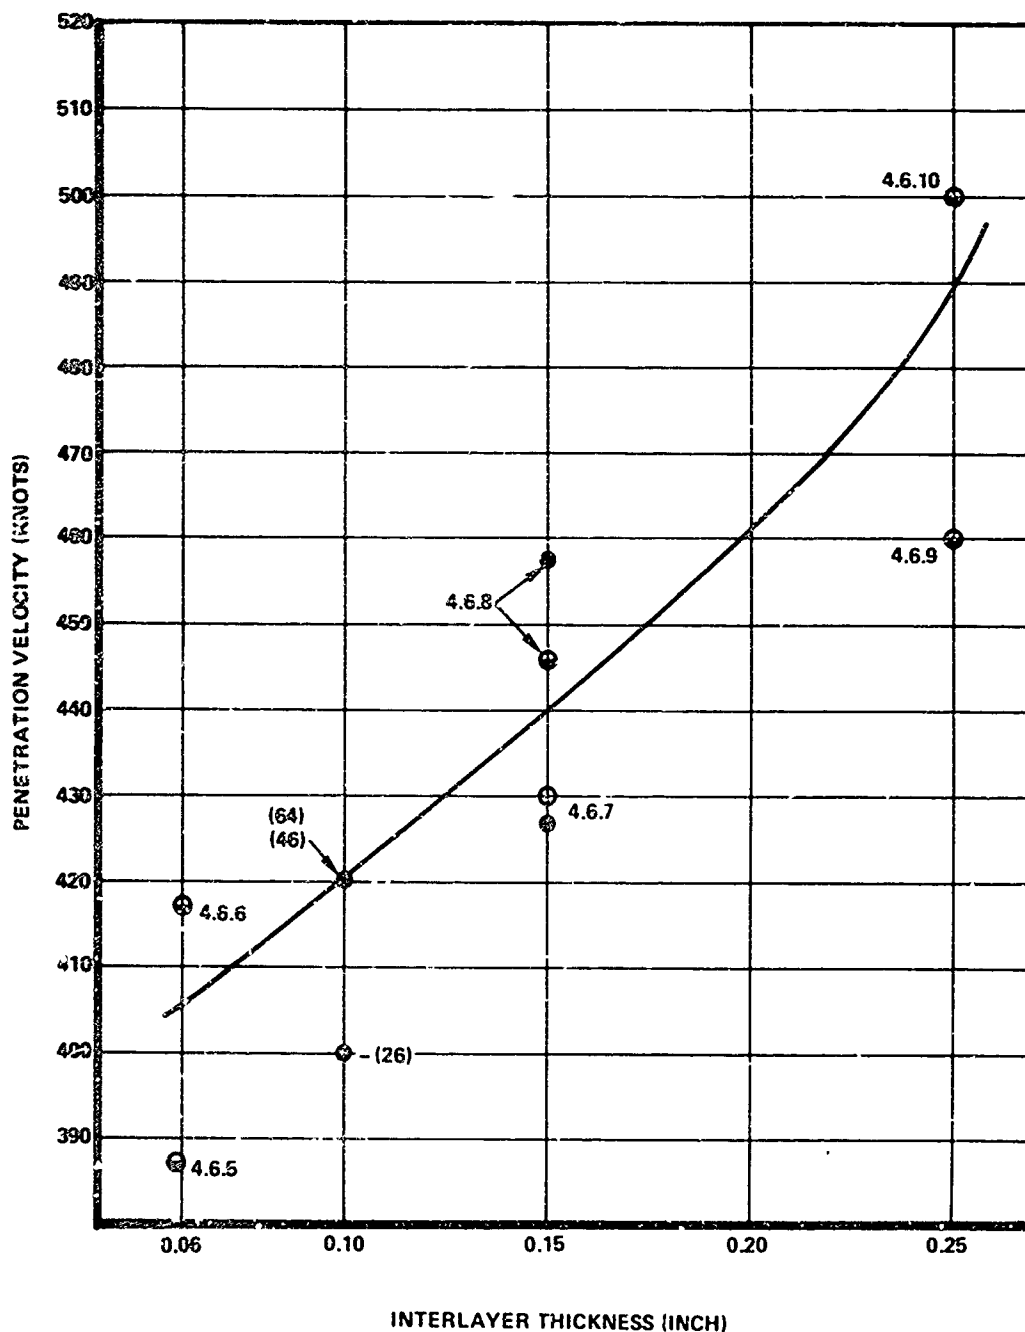
Table 18 tabulates the test results which are plotted in Figure 36. The data point for the 0.10-in. interlayer thickness was obtained from AFML-TR-74-234. Here again, increasing the interlayer thickness increased the penetration velocity. The slope of the curve tends to become steeper as the interlayer thickness increases.

Figure 36. Effect of CIP Urethane Interlayer Thickness on Penetration Velocity at 45-Deg Bird Impact Angle

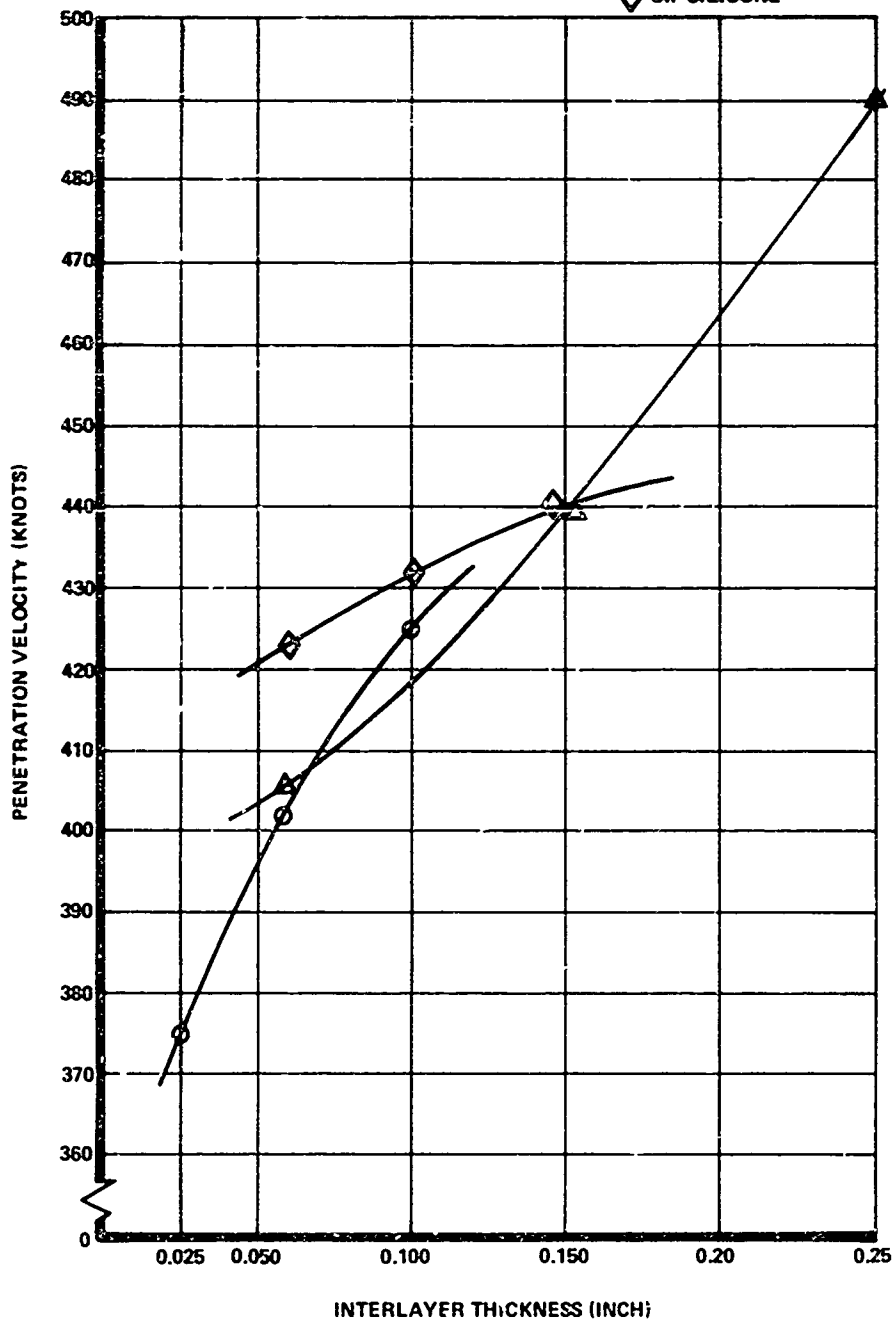
Figure 38 compares the relative performance of the three interlayer types. The ETP sheet interlayer shows lower penetration velocities for 0.025-in. thickness with a sharp increase up to 0.10-in. thickness. The urethane interlayer at 0.06-in. thickness shows essentially the same penetration velocity as ETP with a sharp increase to 0.25-in. thickness. The penetration velocity of the silicone series at 0.06 in. thickness is somewhat higher than both the ETP and urethane interlayers but exhibits a more gradual slope as thickness increases. The tailing off of the silicone interlayer is probably due to the lower tear strength of this interlayer. The increased toughness of both the ETP and urethane interlayers makes them more effective as their thicknesses increase.

Figure 38. Effect of Interlayer Type and Thickness on Penetration Velocity at 45-Deg Bird Impact Angle

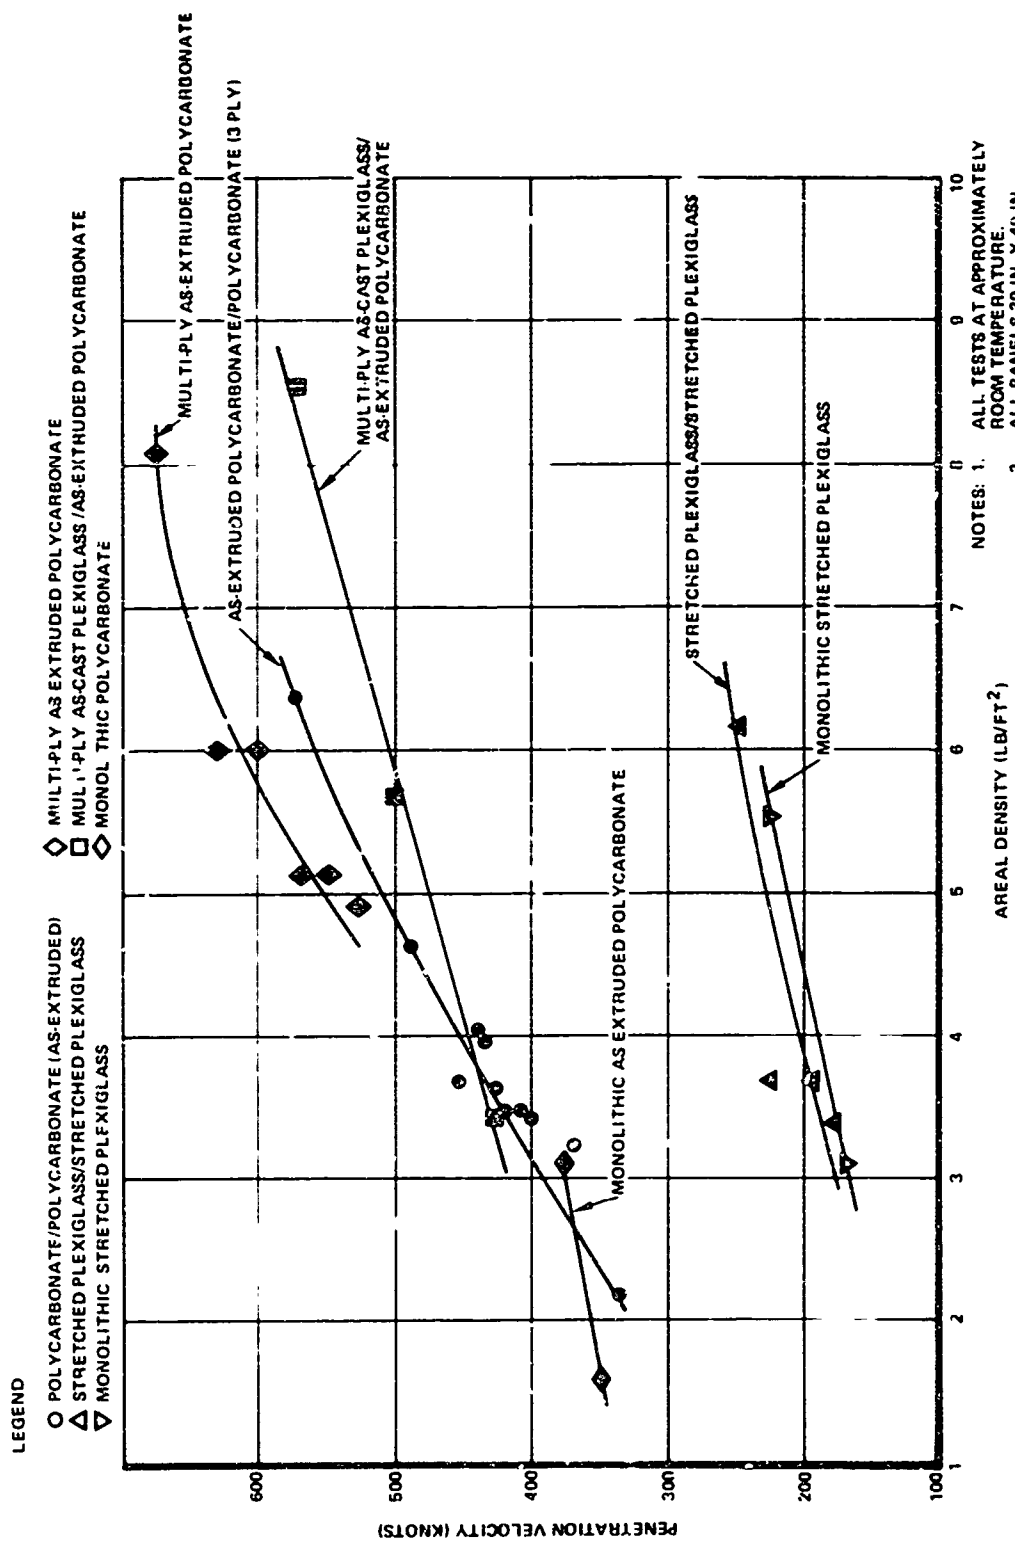
In the study of armor systems, one of the means to measure the relative performance is to compare the unit weights of each system required to defeat a specific threat. This same concept can be used to establish the relative bird impact performance of the various types of transparency materials and construction methods. Figure 41 presents such a plot based on the tests of the

Figure 41. Penetration Velocity versus Areal Density of Flat Laminated and Monolithic Panels at 45-Deg Bird Impact Angle

30-in. x 40-in. flat panels at the 45-deg bird impact angle. The comparative efficiency of each material and construction type can be readily determined from this figure. Monolithic and composite construction types are included. The composites include balanced three-ply laminates and multi-ply (more than three-ply) laminates.
